# Asbestos R&D Survey Report

Reference No: PN21096

## The Pavilion

## Owslebury Parish Council

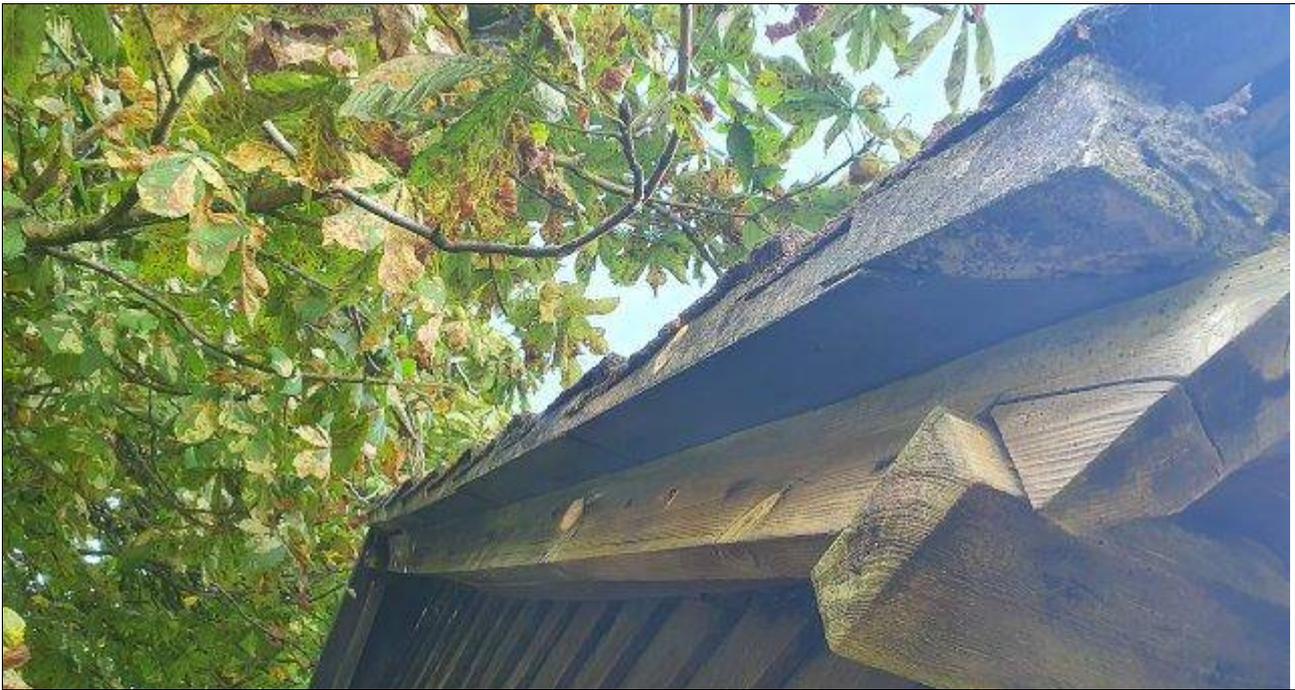
Area Entry Number	13	Date of Inspection	21 September 2021
Sample No / Other	Sample 02	Floor/Level	Ground Floor
Inspected By	Peter Hajduga	Estimated Extent	08 lm
Sample Location	Cement undercloaking		
Area / Title	Building - Old Build Home Team Side

Wgt
Product Type	Cement Products	0
Surface Treatment	None	3
Extent of Damage	None	0
Asbestos Type	Chrysotile	1

Risk Factor	4	Risk Band	C	HSE Notifiable	No	Labelled	No
Advised Actions	ACM's should be removed by a suitably qualified contractor. The work does not require a license under the CAR 2012 however the waste should be disposed of appropriately

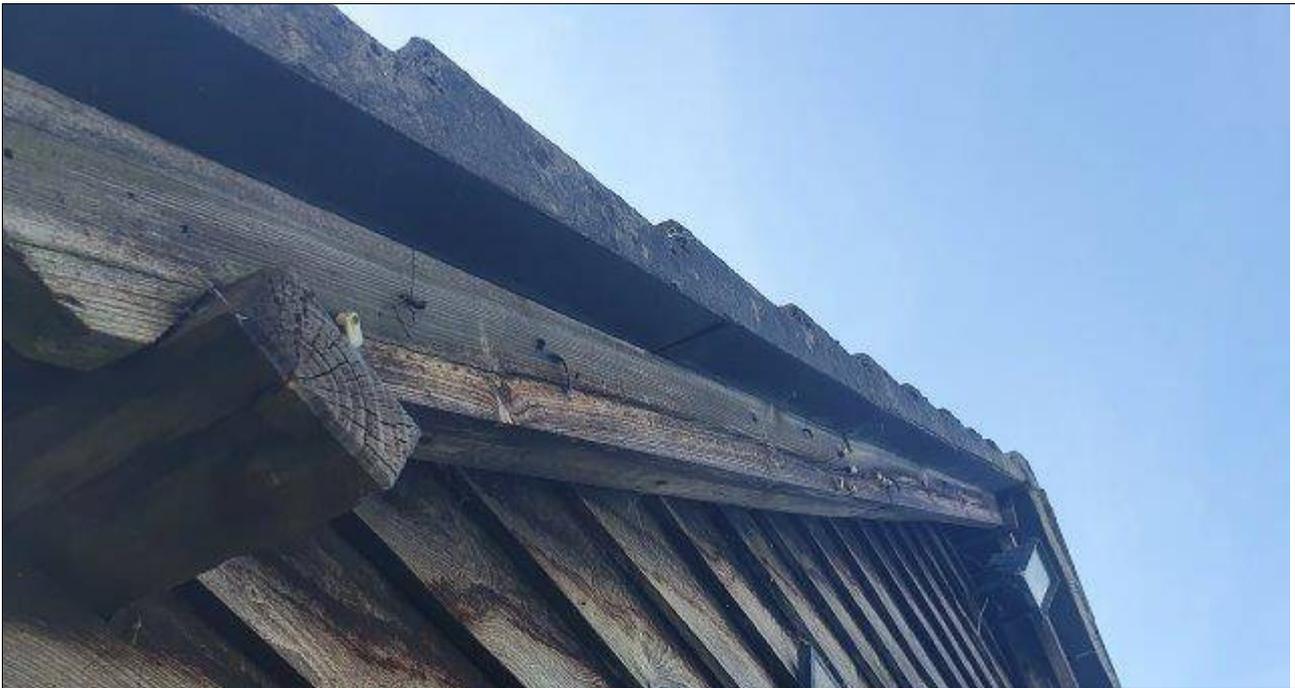
Area Entry Number	14	Date of Inspection	21 September 2021
Sample No / Other	Referred to sample 02	Floor/Level	External
Inspected By	Peter Hajduga	Estimated Extent	08 lm
Sample Location	Cement undercloaking		
Area / Title	Building - Old Build Away Team Side

Wgt
Product Type	Cement Products	0
Surface Treatment	None	3
Extent of Damage	None	0
Asbestos Type	Chrysotile	1

Risk Factor	4	Risk Band	C	HSE Notifiable	No	Labelled	No
Advised Actions	ACM's should be removed by a suitably qualified contractor. The work does not require a license under the CAR 2012 however the waste should be disposed of appropriately
